# *Bungalow Inspections*

## Property Inspection Report

123 Anywhere , Lithia, FL 33547  
Inspection prepared for: Sample Report  
Real Estate Agent: -

Date of Inspection: 4/9/2024 Time: 8:30 AM  
Age of Home: 2005 Size: 3032  
Order ID: 4741

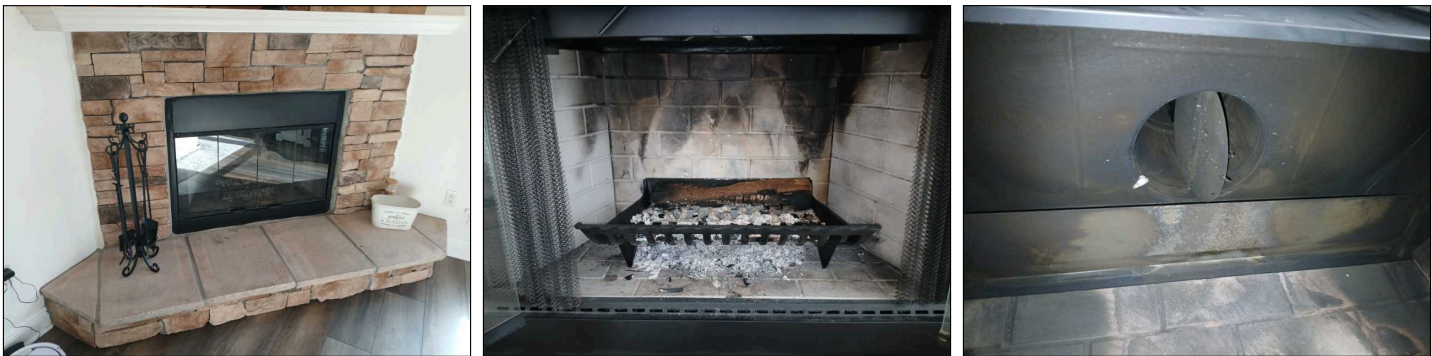
Damper was opened and closed several times.

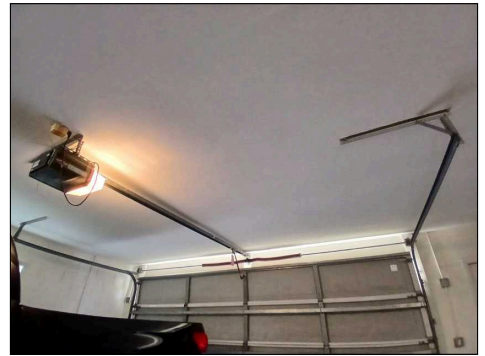
- Joint seam tape cracks noted. Typically, caused from the drying/ curing process of the drywall mud. Recommend filling and painting as needed.

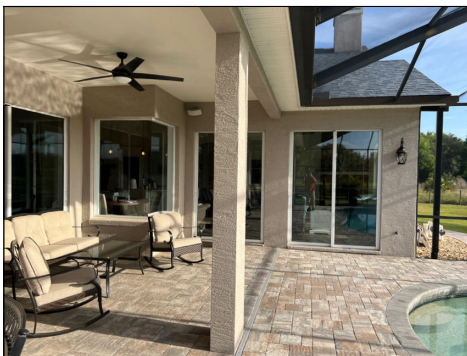
Suggest caulking around doors or windows as necessary.

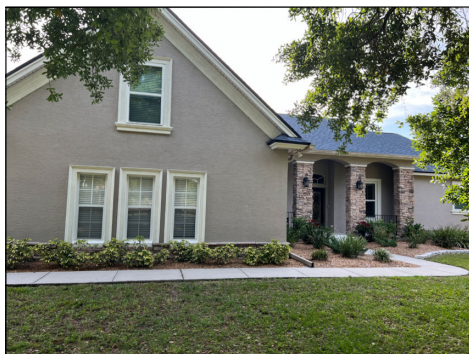
Brick/Stone siding common areas for cracks and water penetration. These areas should be checked annually for cracks, filled and sealed to keep moisture from penetrating the wall structure.

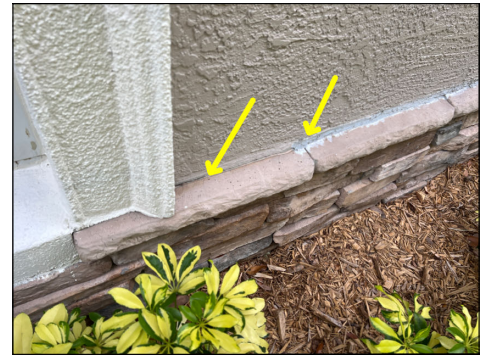
Brick/Stone siding common areas for cracks and water penetration. These areas should be checked annually for cracks, filled and sealed to keep moisture from penetrating the wall structure.

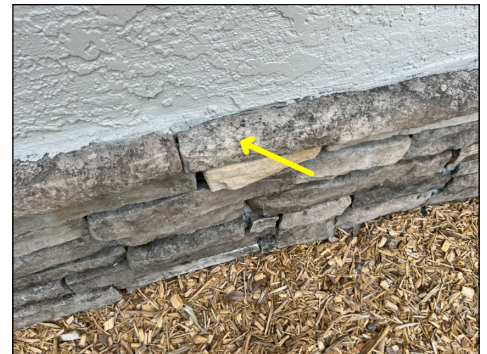
Brick/Stone siding common areas for cracks and water penetration. These areas should be checked annually for cracks, filled and sealed to keep moisture from penetrating the wall structure.

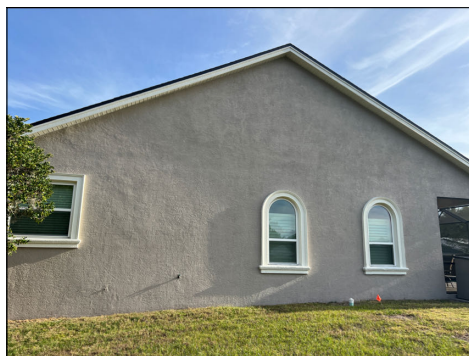
Brick/Stone siding common areas for cracks and water penetration. These areas should be checked annually for cracks, filled and sealed to keep moisture from penetrating the wall structure.

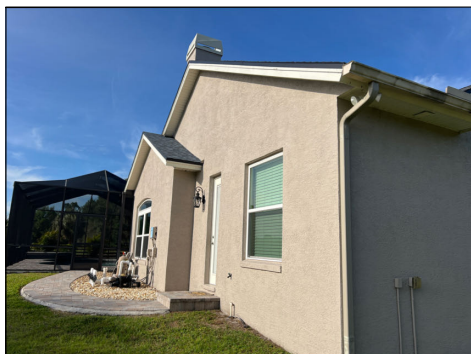
Brick/Stone siding common areas for cracks and water penetration. These areas should be checked annually for cracks, filled and sealed to keep moisture from penetrating the wall structure.

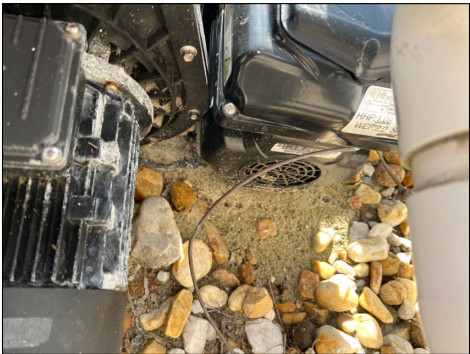
Bonding in place and appears functional

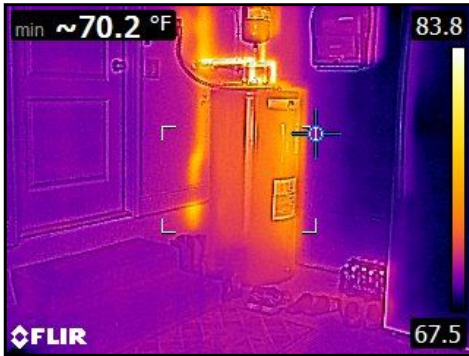
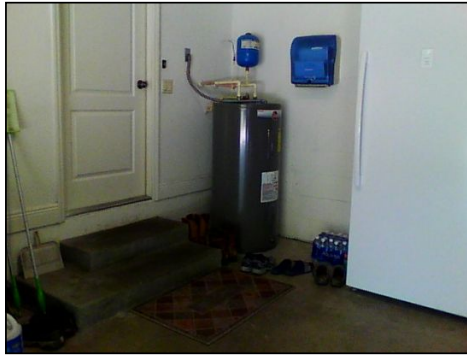
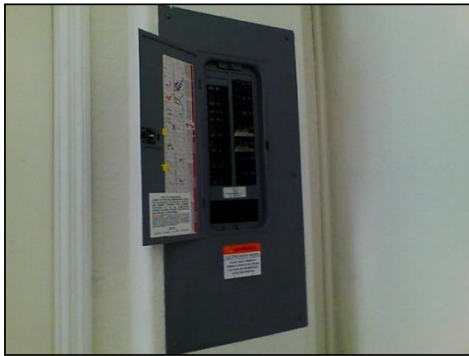
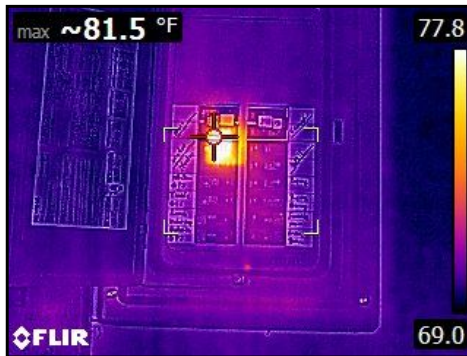
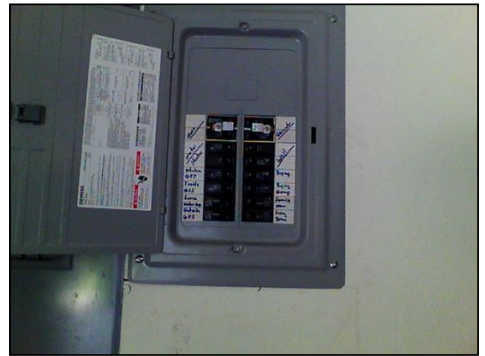
No overheating noted
