# *Bungalow Inspections*

## Property Inspection Report

1234 Anywhere St , Lakeland, FL 33810  
Inspection prepared for: Happy Homeowner  
Real Estate Agent: -

Date of Inspection: 1/29/2022 Time: 1:00 PM  
Age of Home: 1995 Size: 1775  
Weather: Sunny 55 degrees  
Order ID: 2754

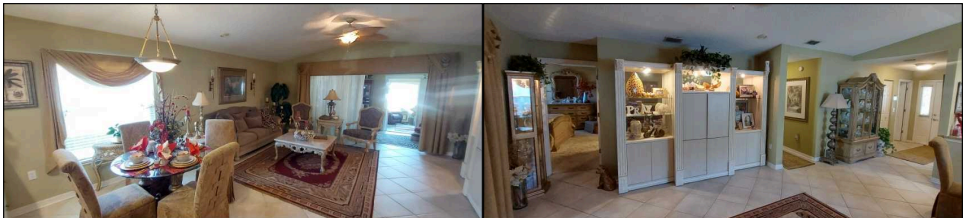
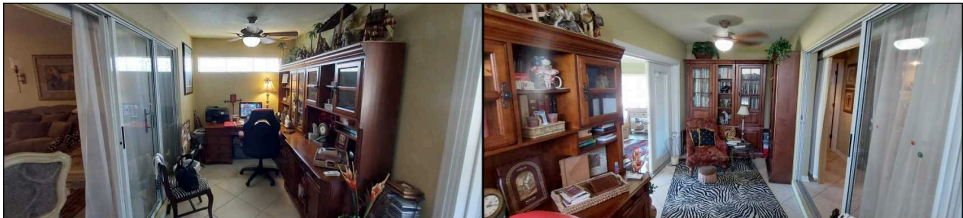
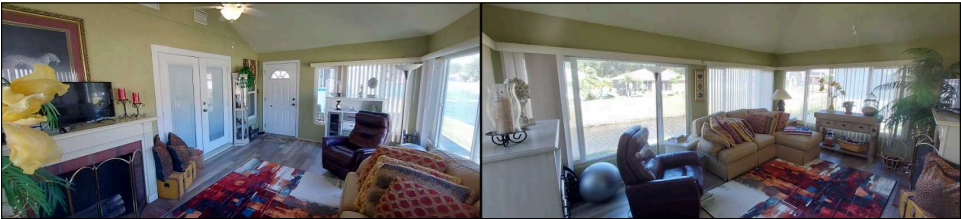
Materials: Drywall walls noted.

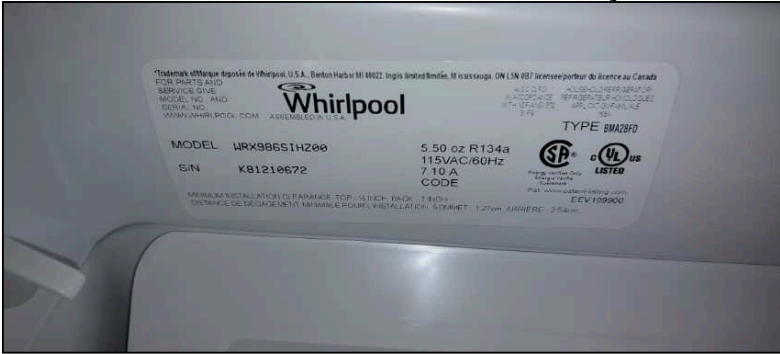
Observations:  
• This unit was tested and appeared serviceable at time of inspection. See Infrared temperature readings for Fridge and Freezer. Inspection does not include calibration as this is not a technically exhaustive inspection.

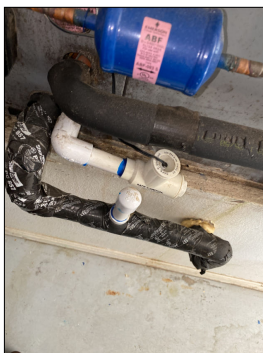
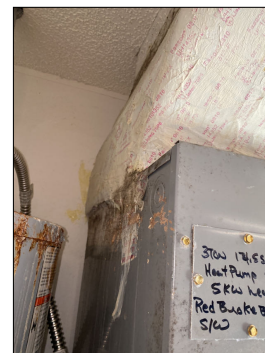
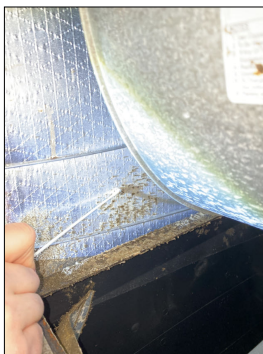
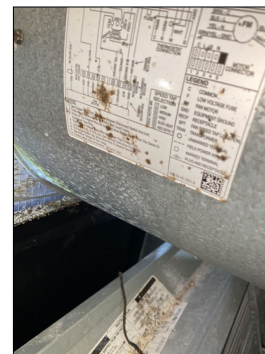
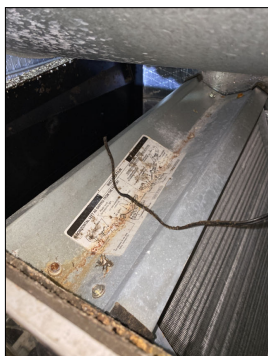
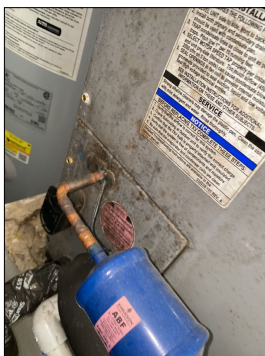
• Air Leaks noted around enclosure, have sealed up for energy efficiency and to keep dirty air from bypassing the filter, by a licensed HVAC technician.

• Mold-like bio growth observed. Professional testing & evaluation advised. If further information is desired to determine the growth material, we can help with testing from one of our lab partners. Please contact us for further information if desired.

Air Leaks noted around enclosure, have sealed up for energy efficiency and to keep dirty air from bypassing the filter, by a licensed HVAC technician.

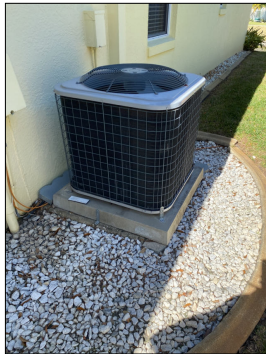
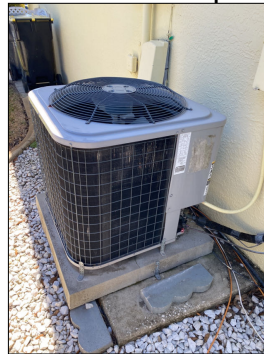
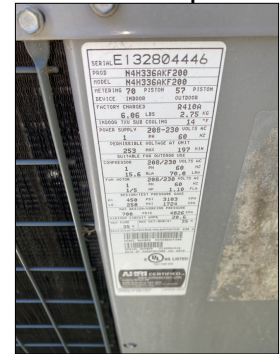
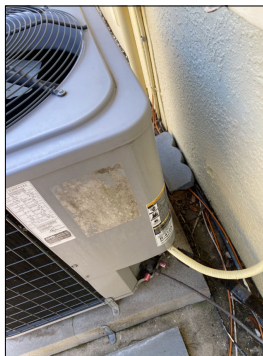
• The typical temperature differential split between supply and return air in an air conditioner of this type is 15 - 20 degrees F. This system responded and achieved an acceptable differential temperature of 19 degrees F.

• Amp test rating within normal operating range at the time of inspection.

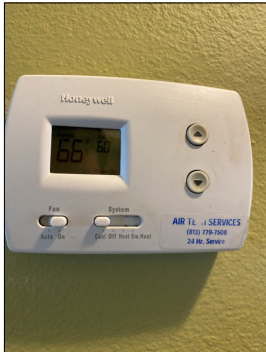
- Observations:
- Location: Hallway
  - Digital - type.
  - Thermostat was put into all modes from heat, cool and off mode and found to be in serviceable condition at the time of inspection.
  - Functional at the time of inspection.
  - Thermostats are not checked for calibration or timed functions.
  - Current temp reading 66 Degrees at 1:19 pm

Current temp reading 66 Degrees at 1:19 pm

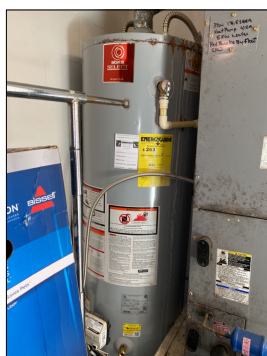
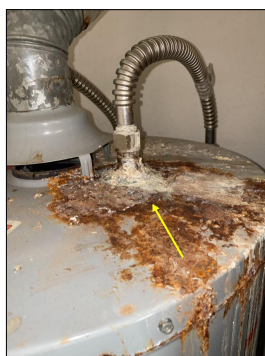
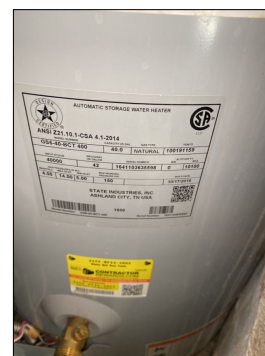
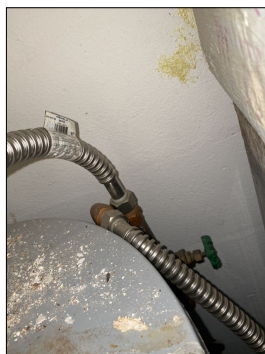
- Heavily Rusted signs of previous water damage. The water heater enclosure or base is rusted, due to prior water infiltration, condensation or precipitation. Recommend licensed plumber evaluate.

Heavily Rusted signs of previous water damage. The water heater enclosure or base is rusted, due to prior water infiltration, condensation or precipitation. Recommend licensed plumber evaluate.

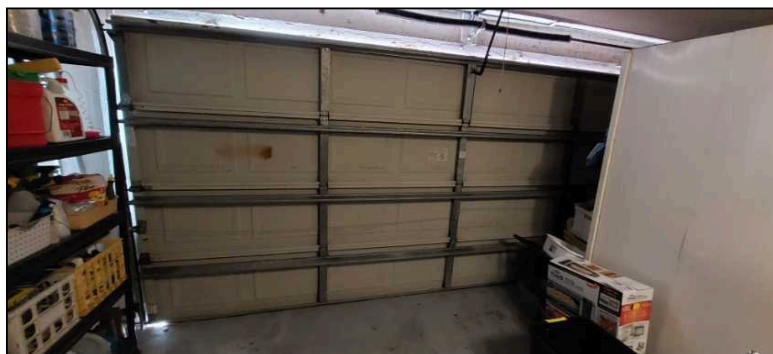
- Garage door weatherstripping is missing or damaged. Recommend repair or replacement to keep water and animals out.

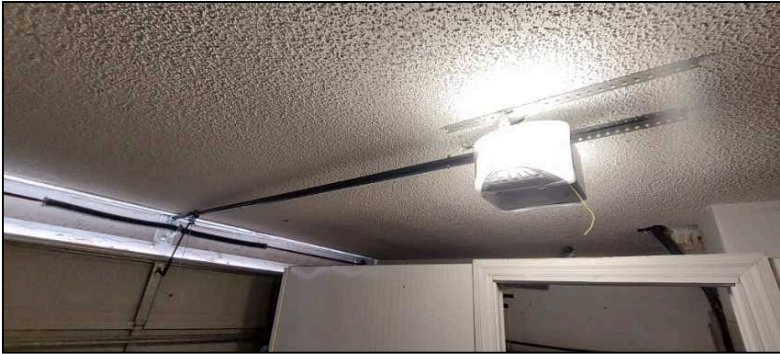
- Belt drive opener noted.
- Appeared in serviceable and functional condition using normal controls, at time of inspection.

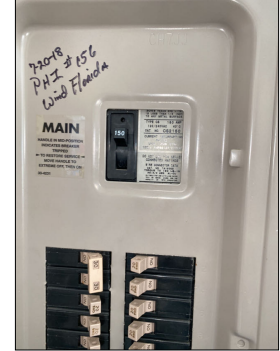
- No major system safety or function concerns noted at time of inspection at main panel box.
- Personal items prevent interior inspection n/a.

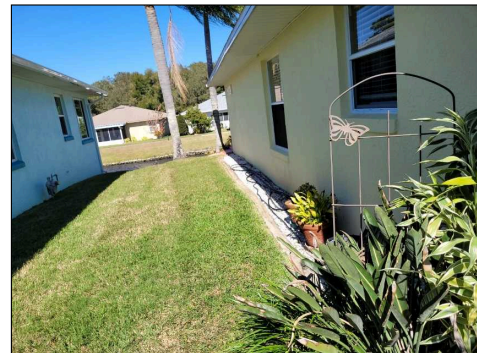
- There is an underground service lateral noted.
- No major system safety or function concerns noted at time of inspection.

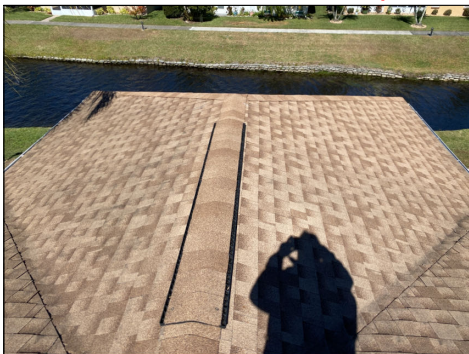
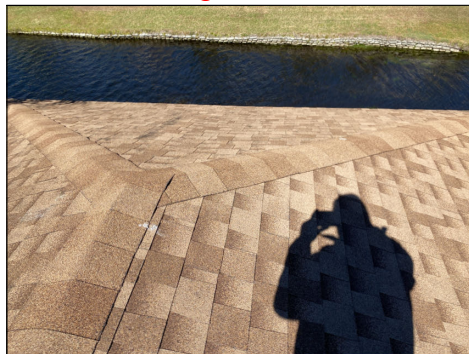
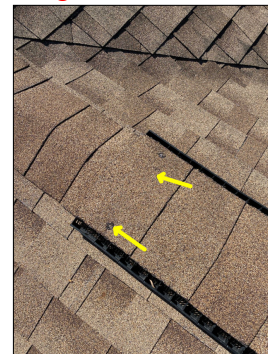
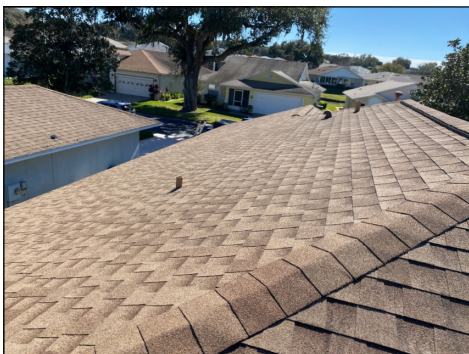
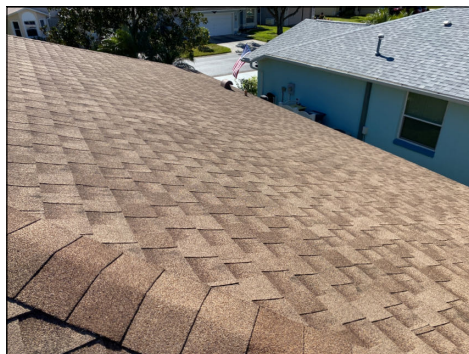
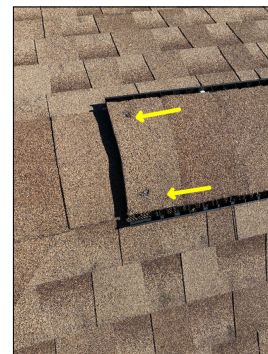
- No major system safety or function concerns noted at time of inspection.
- Estimated Age: 6 years
- Inspector estimates 10 plus years of life expectancy of roof with proper annual maintenance.
- **Exposed nails on roofing material. Recommend sealing all fastener heads.**

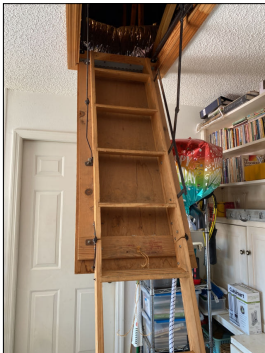
- Pull Down Ladder located in: Garage

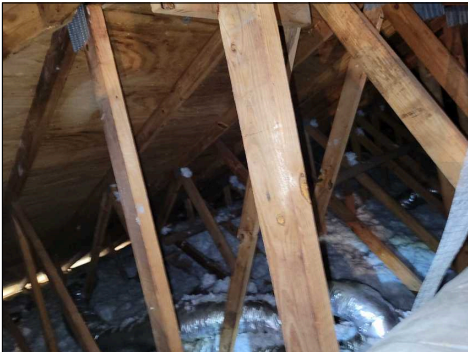
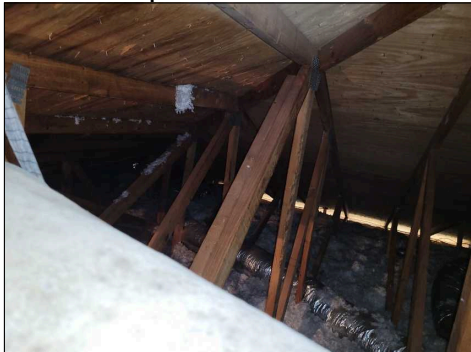
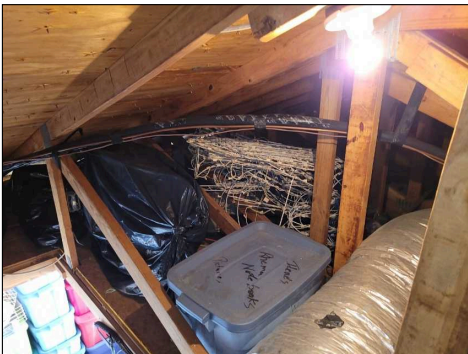
- Attic was physically traversed by inspector to all accessible points. Some areas due to space/size limits, covered with insulation were not inspected (I.E. the outer edge where the truss/rafters met the eaves, vaulted ceilings etc). Appeared in serviceable condition the time of inspection.

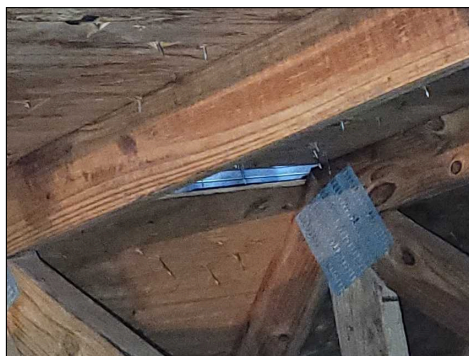
- Under eave soffit inlet vents noted.
- Ridge exhaust venting noted.

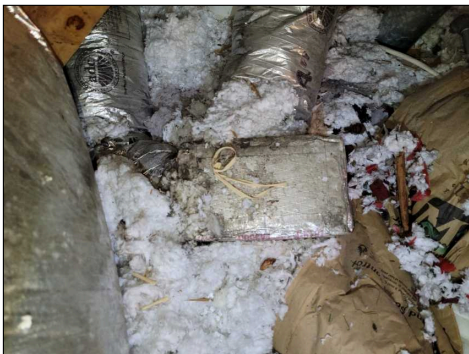
- Leaks noted in duct work, have repaired by a licensed HVAC contractor.

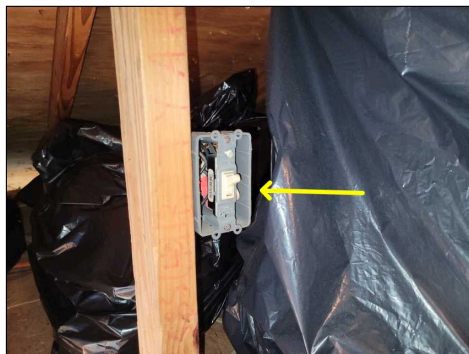
- Appeared in serviceable condition the time of inspection. Limited view due to most areas not visible due to insulation.
- Electrical Box Covers missing or damaged, which is a potential shock or electrocution hazard.

Electrical Box Covers missing or damaged, which is a potential shock or electrocution hazard.

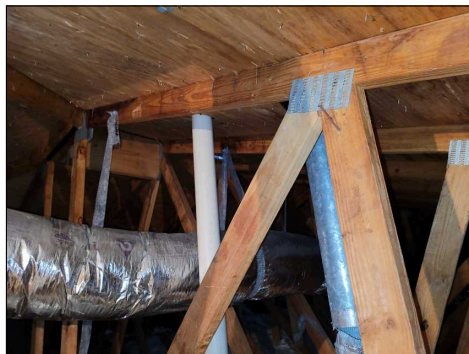
- **PVC** plumbing vent pipe appeared functional, at time of inspection.

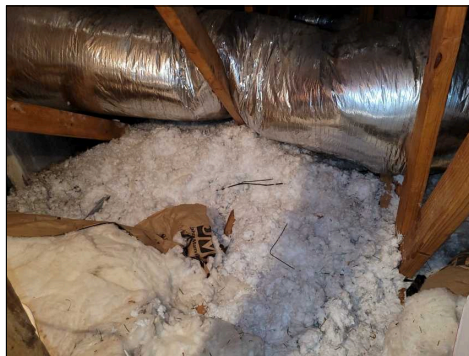
- Appeared in serviceable condition at the time of inspection.

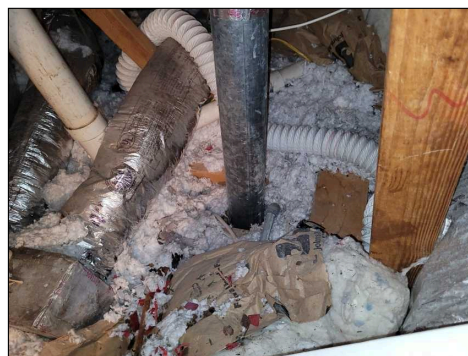
- **Dryer Exhaust fan duct appears to terminate in attic. Have duct routed to exterior to minimize moisture an possible development of mold.**

Exhaust fan duct appears to terminate in attic.  
Have duct routed to exterior to minimize moisture  
an possible development of mold.

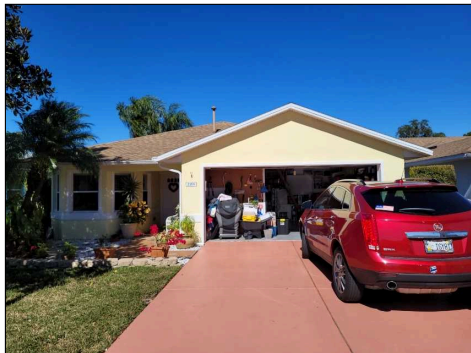
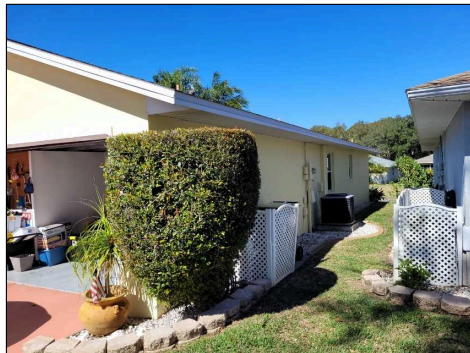
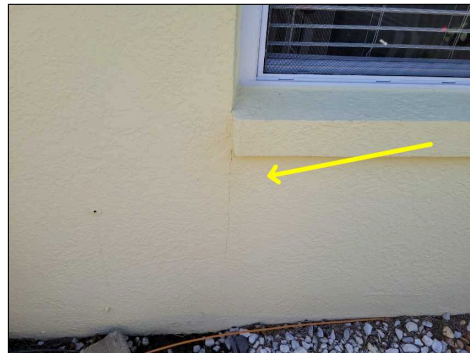
- The exterior stucco appears to have some small cracks on the surface. Stucco is a paintable surface, and based on the condition we suggest doing so as paint can fill in the cracks and seal them up and keep water and moisture from penetrating the wall structure.
- Stair Step cracks noted. No Rotational or Shifting noted at the time of inspection. Fill and paint as needed

Fill and paint cracks

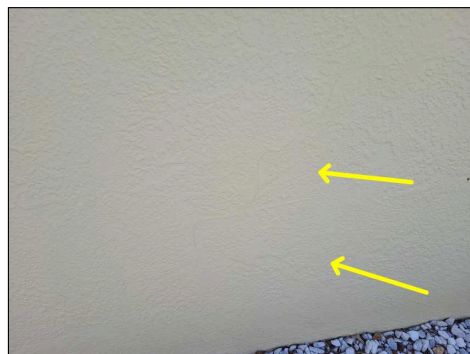
Stair Step cracks noted. No Rotational or Shifting noted at the time of inspection. Fill and paint as needed

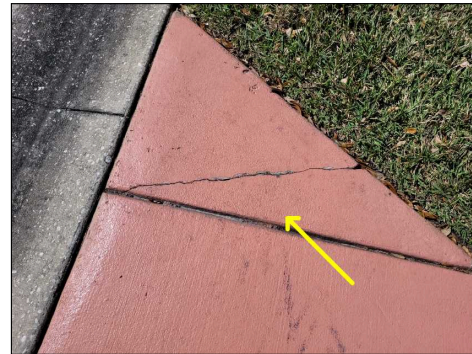
• Minor settlement, or "hairline" cracks in driveways, are normal for properties of any age. They should, however, be monitored for expansion and sealed as necessary.

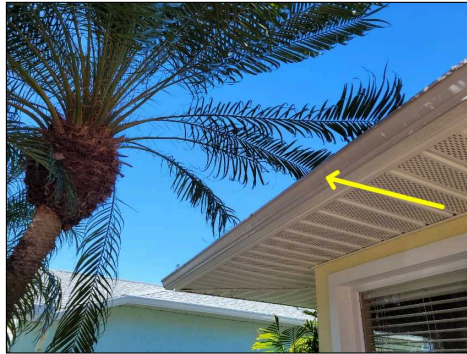
Tree limbs within 10 feet of roof should be trimmed away to provide air and sunlight to roof, while minimizing debris & dampness.

- Prune or remove any plants that are in contact or proximity to home to eliminate pathways of wood destroying insects.
- Trim trees that are in contact or proximity to home, as branches can abrade roofing or siding.
- Tree limbs within 10 feet of roof should be trimmed away to provide air and sunlight to roof, while minimizing debris & dampness.

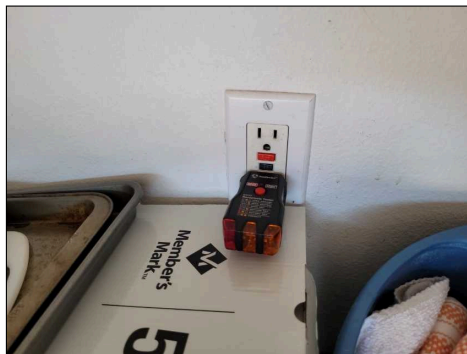
Exterior GFCI resets to garage, and garage outlet would not reset after trip test. Recommend licensed electrician evaluate and repair as needed.

- GFCI outlets tested and functional at the time of inspection.
- Reset is in the garage.
- Exterior GFCI resets to garage, and garage outlet would not reset after trip test. Recommend licensed electrician evaluate and repair as needed.
